NACA RM E52K13

PRELIMINARY INVESTIGATION IN J33 TURBOJET ENGINE OF SEVERAL
ROOT DESIGNS FOR CERAMAL TURBINE BLADES

By George C. Deutsch, Andre J. Meyer, Jr.
and William C. Morgan

Lewis Flight Propulsion Laboratory
Cleveland, Ohio

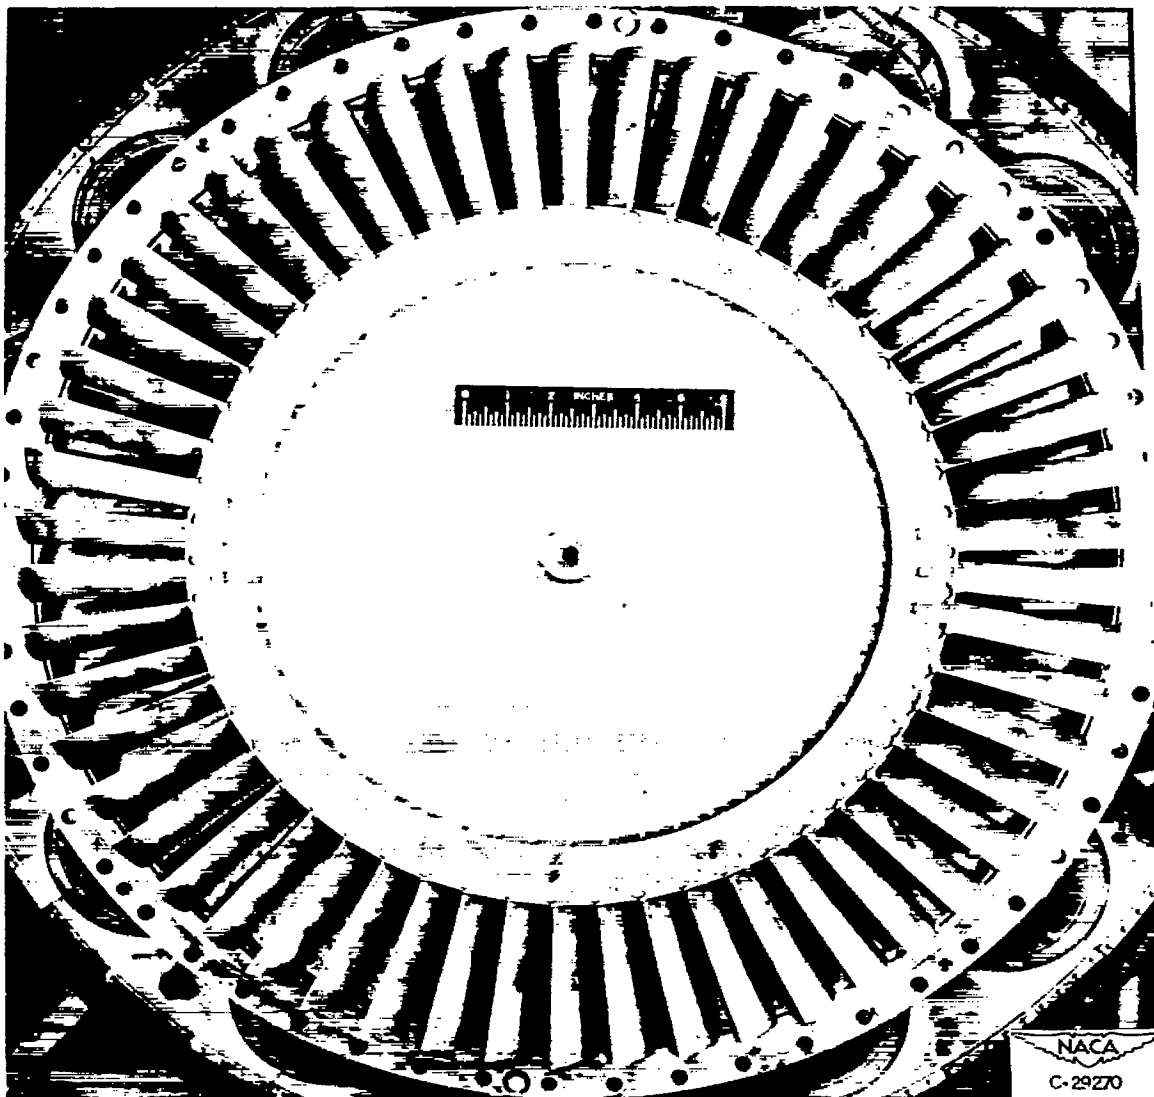
Figure 9. - Ceramal turbine blades having 4-pin type roots prior to operation.

4-pin blade runs. - As in the previous run this wheel was bladed with two diametrically opposed clusters of three ceramal turbine blades (fig. 9). After 1 hour and 40 minutes of operation the fuel pump to the

After 20 hours and 30 minutes at rated speed one blade failed across the top two pins and the fragments damaged the remaining 5 blades (fig. 8(b)). As in run 7, inspection during engine disassembly showed that several of the combustion-chamber-liner retaining pins had failed and that there had been severe damage to the aft end of the engine.
